Ultimate Professional Smart Acoustic Inspection

FOTRIC H7
Acoustic Imaging Cameras

NaviPdM[®] Venus Smart Inspection Assistant

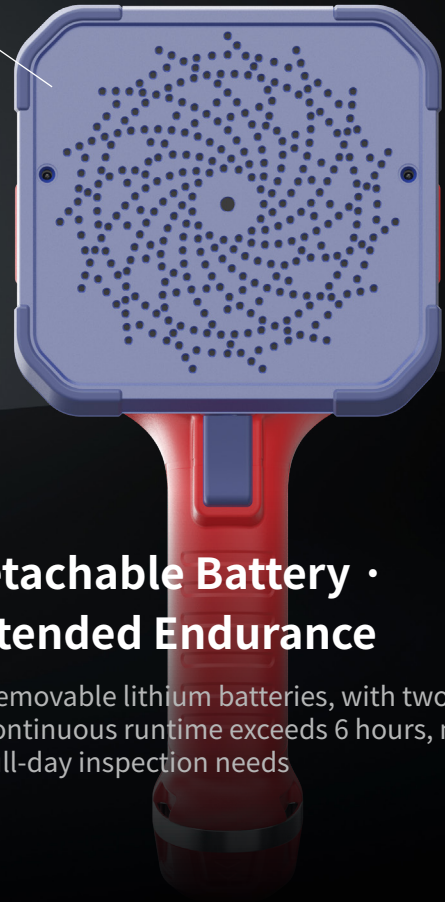
Ultra-Compact Microphone Array

- Spiral topology-optimized array with 345 MEMS digital microphones
- Ultra-high channel count enables wider sound field coverage and finer acoustic mapping, greatly improving inspection efficiency and diagnostic accuracy
- Ultra-long listening range: operational distance from 0.3m to 300m
- Lightweight yet rugged ergonomic design ensures comfortable grip and easy portability

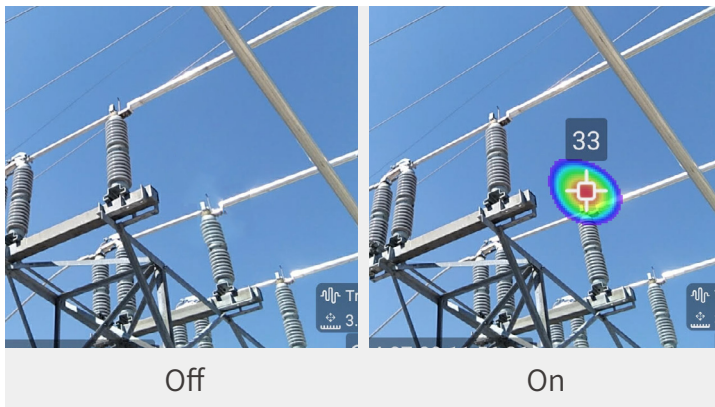
Acoustic Image Delay (T-FFTD®)

Utilizes a multi-modal transient acoustic matrix to enhance microsecond-level acoustic event retention.

Boost signal retention and enhance inspection efficiency for intermittent sound sources.

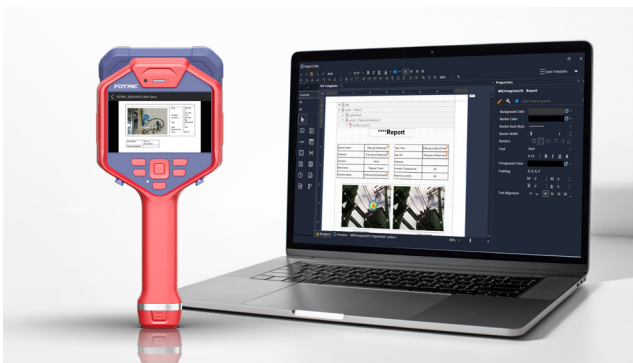
Fast Reporting · On-Device Generation

Directly generates Word or PDF reports on the device, with preview available in the gallery.
